lan Childs Principal, FIREASSESS.AU

# ACTIVE –v- PASSIVE SYSTEMS

Which have more impact upon fire safety

FIRE AUSTRALIA 2022 Conference & Tradeshow

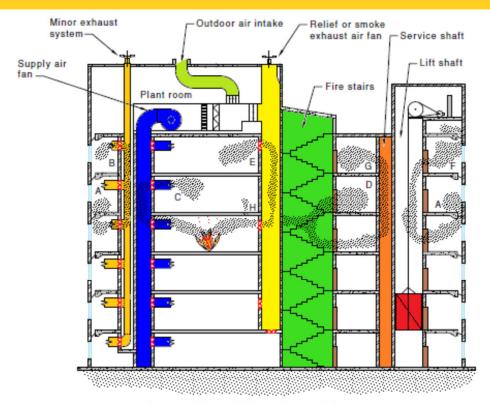
#### **Fire / Smoke Pathways and radiant heat**

#### LEAKAGE PATHS SHOWN ABOVE:

- A Leakage between floors via poorly sealed or return air path
- B Leakage between floors via ductwork of minor exhaust, e.g. toilet exhaust
- C Leakage between floors via supply air ductwork
- D Leakage into fire stairs and then on to typical floors from fire stairs

- E Leakage between floors via relief spandrel
- F Leakage between floors via lift shaft
- G Leakage between floors via service duct or riser shaft
- H Leakage between floors via gaps or cracks in structure

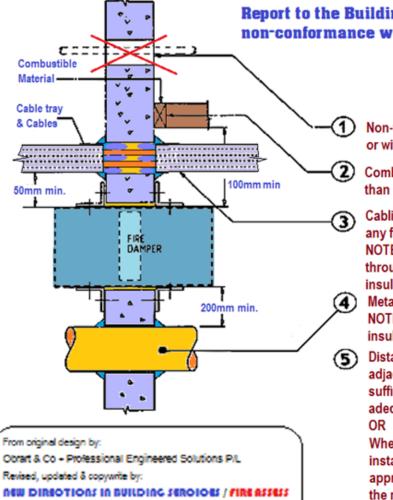
#### **Service segregation / separation**

Report to the Building Owner non-conformance with NCC S13 + AS4072.1

> Non-fire sealed penetration, with or without existing services

> Combustible material not closer than 100mm to any fire damper

Cabling not closer than 50mm to any fire damper. NOTE: Cable tray must not pass through the fire wall or must be insulation wrapped either side Metal pipe (charged) NOTE: if uncharged must be

insulation wrapped either side

Distance between openings for adjacent fire dampers must be sufficient to maintain the structural adequacy of the wall

Where fire dampers must be installed close together, obtain an approved performance solution for the modified wall construction

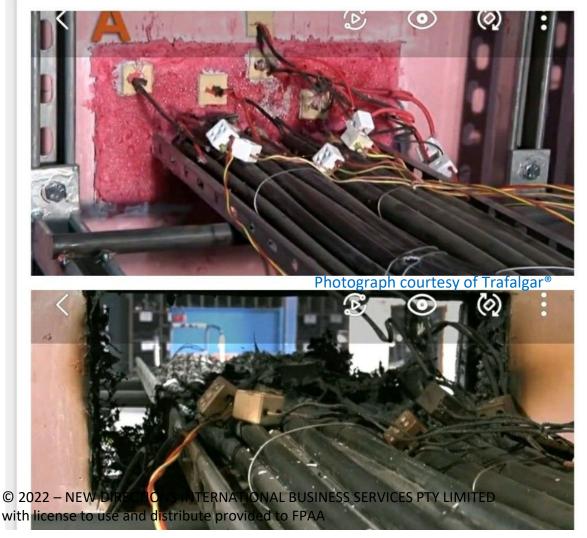
#### Compromised

**One hour** so called FR Foam! Fire tested to AS1530.4-2014

**No** capability to stop fire degradation nor the products of combustion, not provide a thermal insulation barrier.

Installers also have a duty of care which they clearly breach when using this or similar product without reading the small print.. (masonry~masonry only for small gaps)
