non-intrusive investigations...

When it comes to assisting our client's needs, **NEW DIRECTIONS IN BUILDING SERVICES® [NDIBS]** **NEW DIRECTIONS IN BUSINESS SAFETY® FIRE ASSESS®** is committed to keeping up with the latest technologies. In certain cases it may prove beneficial to utilise an infrared thermography camera for non-intrusive investigation.

Non intrusive IR investigations

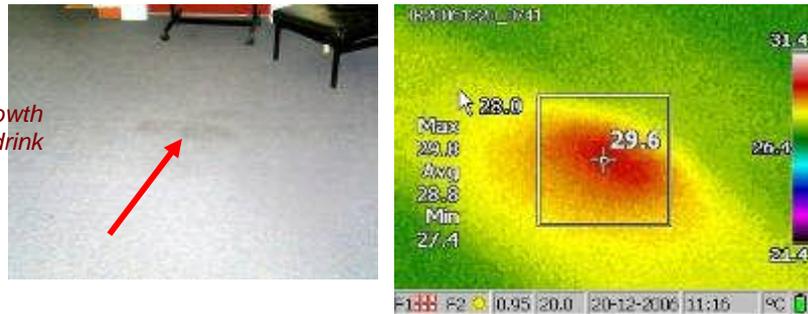
*Microbial Growth
from a spilt softdrink*

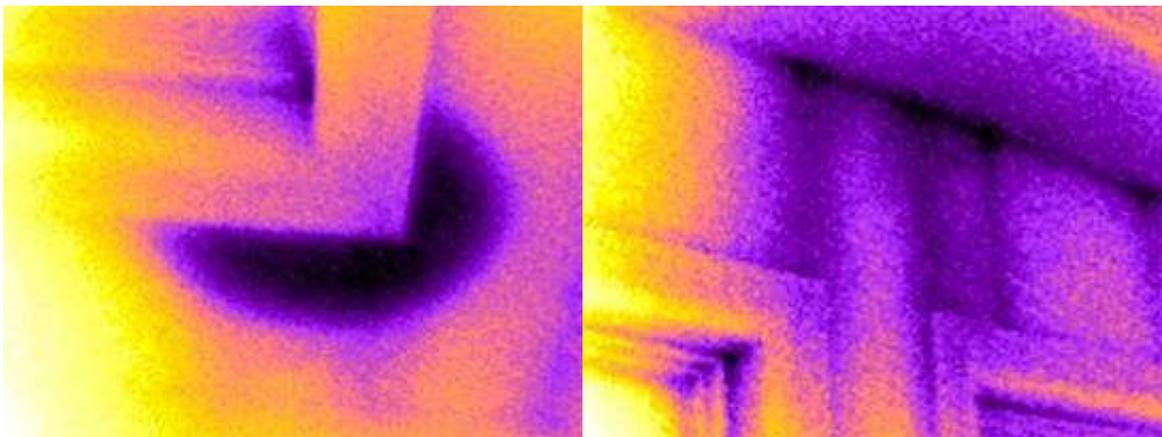
Similarly, it is possible to detect moisture located behind interior walls with an infrared camera, under the right conditions. The temperature difference created by the presence of moisture on the inside surface of a wall will appear differently than the surrounding area.

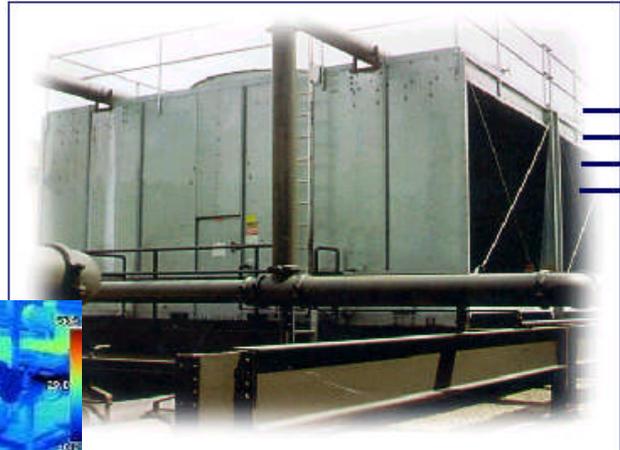
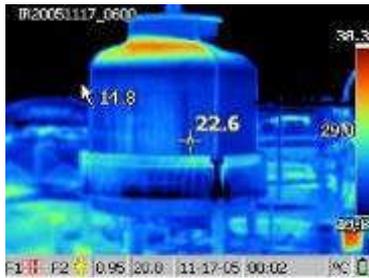
A recent example of the usefulness of this tool was, when occupants of a large residential complex complained about the noise of the condenser water gurgling through their ceilings, the take-off (swaging) connection tails were identifiable as penetrating into the condenser header pipes to such an extent that they were obstructing the downstream waterflow and creating the noise problems (**defect**)

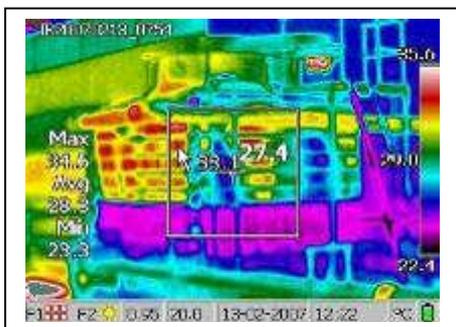
Here Elevated hot deck temperatures are attributable to the operational setpoints for the Screw Chillers in excess of those recommended. Uneven face temperatures suggest “fill” degradation

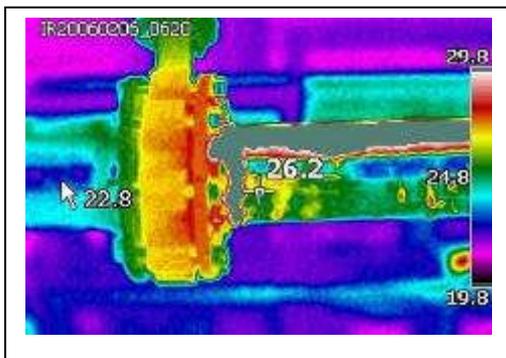
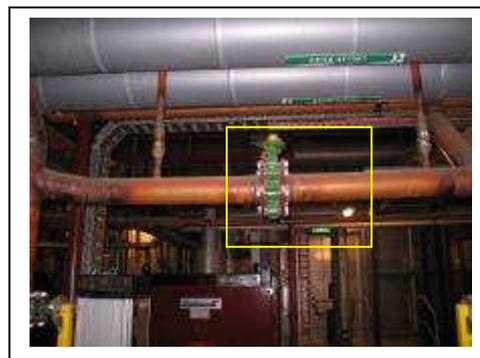
Here we have a clearly identified “dead-leg” and as it is part of a condenser water reticulation system, significantly increases the risk of microbial / legionella exposure.

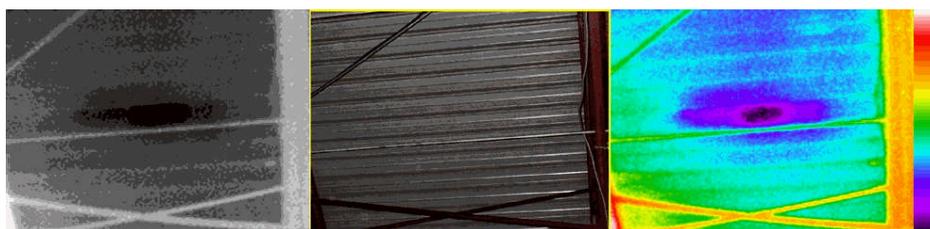
The type of insulation used on a roof will result in an infrared image that is characteristic of how that particular insulation absorbs water. Absorbent roof insulation acts similar to a sponge. The water migrates by capillary action throughout a complete roof board before it jumps to the adjacent board. This results in a checker board thermal pattern.

Non-absorbent roof insulation creates a much different pattern when it becomes wet. The water is not absorbed and runs to the edge of the roof board. The water tends to collect at the edges of the boards resulting in a window frame pattern. Different patterns may result from other less common insulating systems.

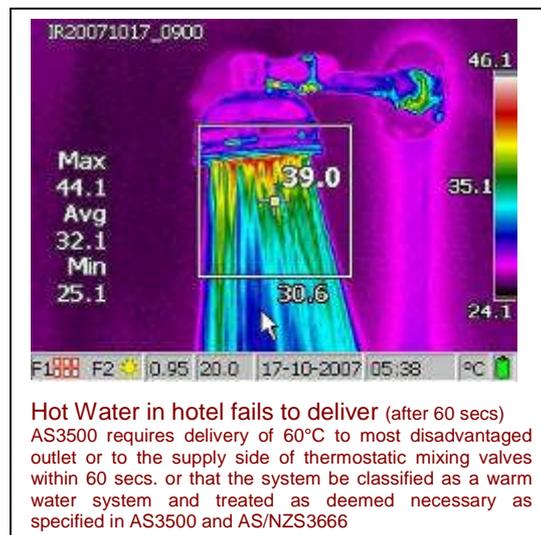
We use infrared thermography to assess performance of refrigeration, water chillers, air handlers, hot water systems, etc. and it is only by the broad knowledge of our operators, that this may be properly assessed. eg. The critical temperature of HCFC-R22 refrigerant is 98°C – if we see that at the discharge from a refrigerant compressor – it indicates a significant fault and failure to perform.

An operator without refrigeration knowledge would probably not be able to identify that there was a fault, nor assist in its remediation.

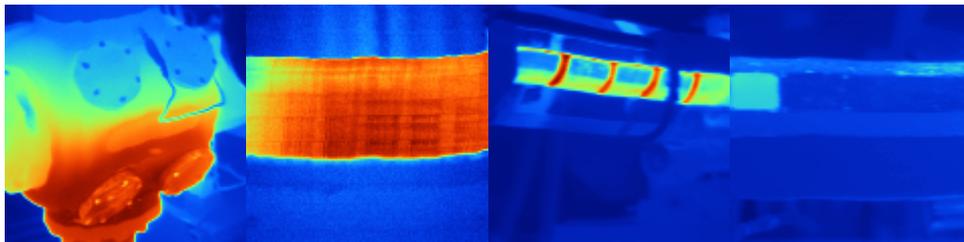
Thermogram **T**) is a natural gas compressor where the cylinder head in the lower left of the picture shows signs of a valve problem. Not counting the bolt head parts of the images, this cylinder head shows a 25°C temperature gradient. This gradient was felt to be excessive and it resulted in a tear down and servicing of the compressor. Thermogram **U**) is an image of a rotating 300mm diameter 900mm long pinion gear that drives a 15 metre diameter drum in a molybdenum mining operation. By monitoring the lengthwise temperature gradient, the technician could monitor the gear alignment and its life expectancy. Thermograms **V**) and **W**) are images of pipe with band heaters. **V**) shows the heaters on and functioning and **W**) shows them not working.

T) Compressor U) Pinion Gear V) Band Heater W) Band Heater

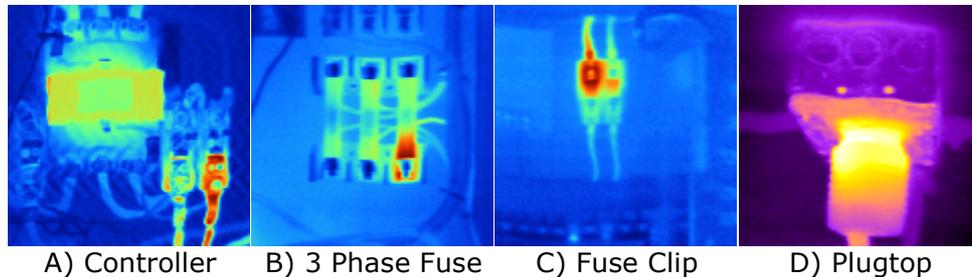
Thermogram **A)** is a motor controller for an elevator in a large hotel. One of the three phase connections was loose, causing increased resistance at the connector. The excess heating produced a temperature rise of 50°C. Thermogram **B)** is a 3-phase fuse installation where one end of one fuse has poor electrical contact with the circuit. The increased contact resistance caused a 45°C hotter temperature at that connection than at the other fuse connections. Thermogram **C)** is a fuse clip where one contact is 55°C hotter than the others. And thermogram **D)** is a plugtop-in which the wire connections were loose causing the terminals to heat 55°C hotter than the ambient.

All four of these examples were serious and needed immediate attention. Thermogram **B)** shows an interesting principal used in interpreting thermal patterns of electrical circuit. The fuse is hot at one end only. If the fuse were hot at both ends, the problem would be interpreted differently. An overloaded circuit, phase imbalance, or an undersized fuse would cause both ends of the fuse to overheat. Being hot at one end only suggests that the problem is high contact resistance at the heated end.

The plugtop in Thermogram **D)** was seriously damaged as seen in the visual picture above the thermographic image, however, it continued to operate until it was identified and due to the associated risks was promptly replaced.

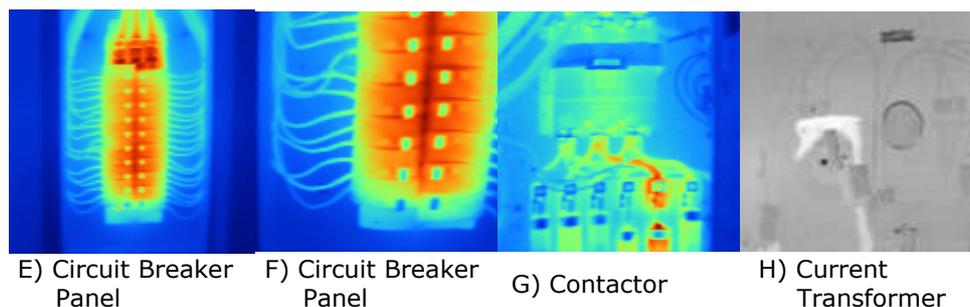
The following thermograms show overloaded circuits. Thermogram **E)** shows a circuit panel in which the main breaker at the top is over heated 75°C above ambient. This total panel is overloaded and in need of immediate attention. Thermograms **E)** and **F)** show all the standard circuit breakers over heated. Their temperatures were 60°C above ambient. Although in the thermogram the wires are blue in colour they are also hot, 45 to 50°C. This entire electrical system needs to be redone.

Thermogram **G**) shows one line of a contactor that is about 20°C above the others. This needs further investigation to determine why one wire is that much hotter than the others are and to determine the repair needed. Thermogram **H**) shows a current transformer that is 14°C warmer than the other two transformers in a 3-phase service installation. This indicates a serious imbalance of the service or a faulty current transformer that could seriously impact the customer's utility bill (demand rate time of use tariff).

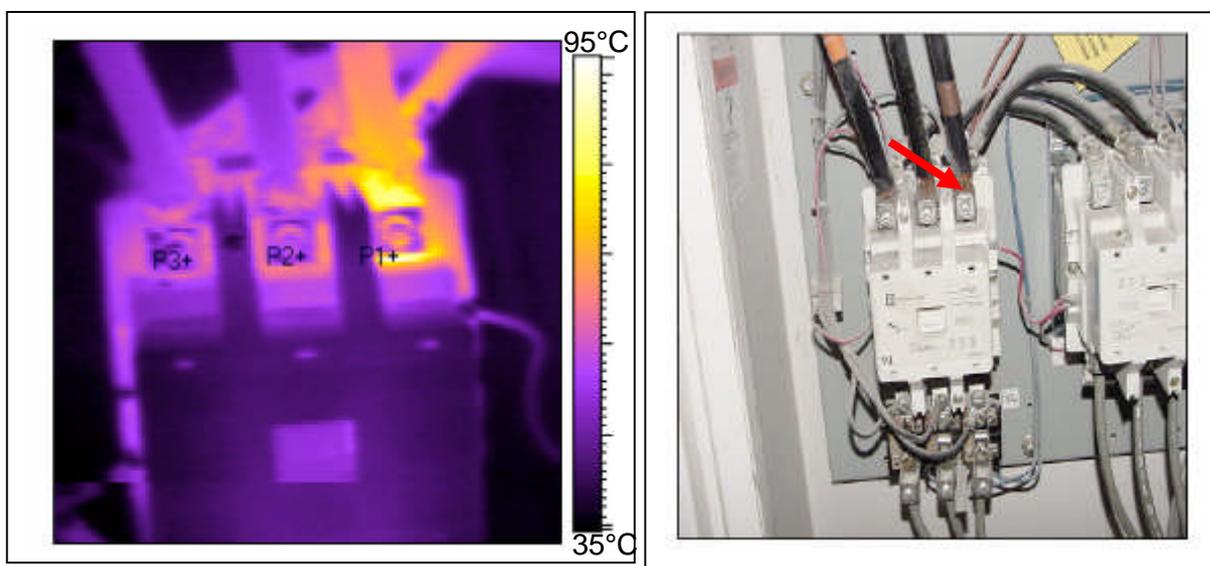
Infrared cameras **cannot see through** cabinets or solid metal bus trays. Whenever possible the open enclosures so the camera can directly see the electrical circuits and components. If you find an abnormally high temperature on the outside surface of an enclosure, rest assured that the temperature is even higher, and usually much higher, inside the enclosure. Following are some thermograms taken of a switchboard cabinet, which identify a serious problem with one phase of the three phase supply connections to the contactor. The hot spot was in the order of 60°C hotter than the ambient and 45~50°C hotter than other parts of the bus enclosure.

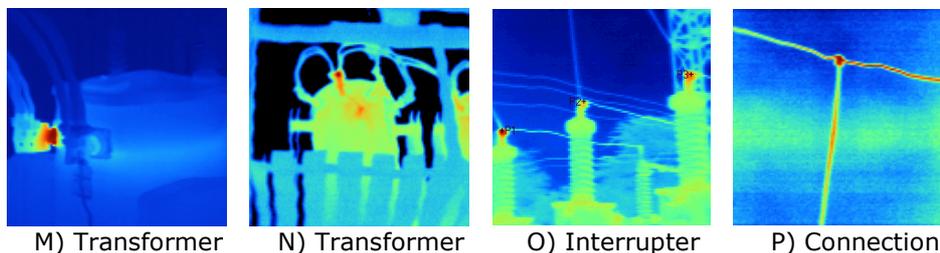
Thermogram **M)** is a service transformer that had leaked some cooling oil, resulting in dangerously over heated coils near the top. One connection was 160°C above ambient. This transformer needed immediate replacement but the company wanted to delay the repair one month so it could be done during a scheduled total plant shutdown. They used the IR camera to monitor the state of the transformer and successfully delayed the repair. Thermogram **N)** is for a pole mounted service transformer that has a connection 30°C hotter than ambient. Such a condition required maintenance at the next convenient opportunity. Thermogram **O)** shows a hot main connection on an interrupter at a substation. The connection was found to be 14°C hotter than the others. This was believed to be a problem that needed attention. Thermogram **P)** shows an overhead connection in a substation. It was less than 10°C above ambient and not of immediate concern.

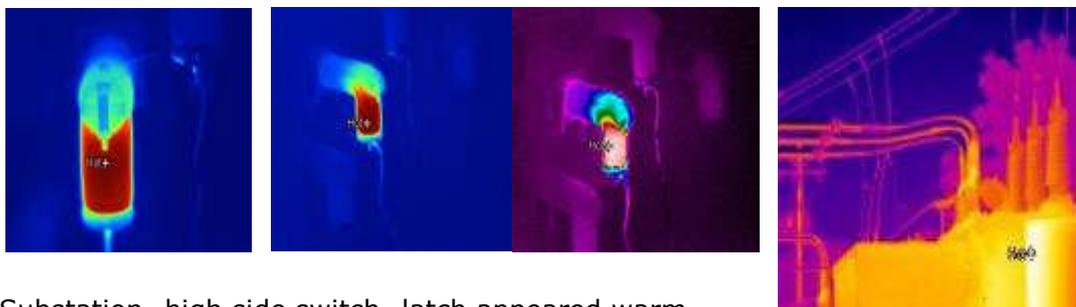
The lower portion of elbow was 46°C above ambient - circuit load was not checked. The warm part is where the elbow is over the bushing, a likely heat source is either the probe and socket or the OCR bushing. This did not appear to be a pin and connector heat source.

Substation- high side switch- latch appeared warm 12°C above ambient.

Infrared imaging and temperature analysis are a necessity to efficiently and accurately monitor substations, power connections, and other transmission equipment. With our IR-SmartCam™ or Flir-i7™ we're allowed to diagnose potential problems before they become catastrophic, saving significant expenses on extensive repairs and downtime. By utilising infrared technology, you will be able to increase reliability, conserve costs, and save money. Below are some sample images of an infrared inspection conducted during a routine predictive maintenance check.

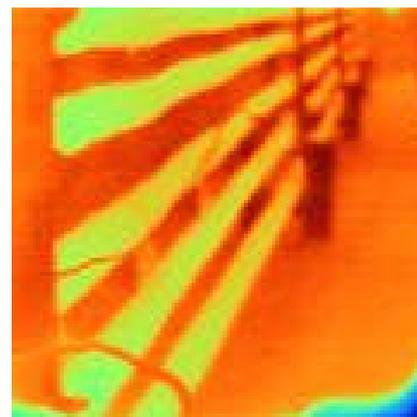
This example shows coke scale precluding the liquid from uniformly absorbing the tube's heat. Additional disadvantages of coking include higher furnace firing rates and decreased tube life. This provides more incentive to maintenance personnel to perform regular infrared scans to protect against this coking and the efficiency gains provide substantial return on the investment costs associated with these inspections and any remedial works.

- **Industrial Process Applications** – Infrared cameras facilitate the inspection of tubes in boilers and condensers for scale build-up. This scaling can easily be detected with suitable high-temperature infrared equipment because areas with scale build-up show up as warmer than other areas of the tube surface.
